innovative Engineers Pave New Paths in Afghanistan

By Major Steven A. Baker

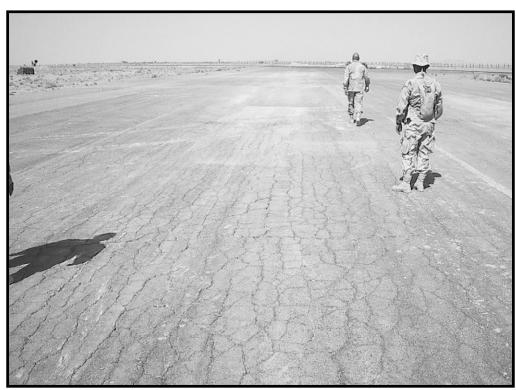
causing the asphalt around those patches to crack excessively. (See Engineer, July 2002, page 8) The cracks were due to the cold joint between the flexible asphalt pavement and the rigid Portland cement patches. While this technique kept the runway open for the first deployments and resupply, it created unacceptable debris after the summer relief in place of major combat forces. This method of repair—aggravated by extreme temperature swings between the day and the night and extremely dry air—did not provide a suitable long-term solution.

Task force engineers inspect a damaged section of asphalt.

first significant method involved cleanly cutting and removing damaged areas, setting the concrete form inside the hole, and then filling the resultant gap between the asphalt and the Portland cement patch with cold-patch asphalt. The technique creates a flexible, easily maintained joint and a repair that can withstand thousands of sorties of traffic with only minimal additional maintenance.

The first step of the method is cutting out and excavating the damaged areas of asphalt. The key to this step is the use of a concrete saw with a diamond-tipped blade to create clean, linear cuts and a skid steer loader to quickly excavate the damaged asphalt down to the subgrade. The subgrade is then compacted and additional fill gravel is added so that the concrete patch created

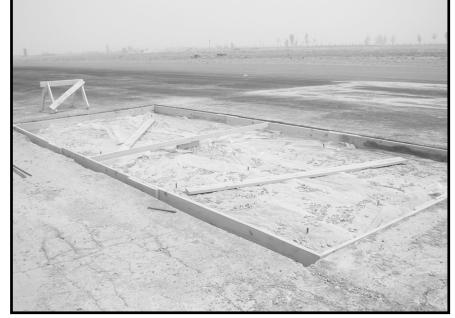
Offset framework, complete with vapor barrier, is ready for the arrival of the concrete truck and crew.

will be 8 to 10 inches thick. The form is cut and installed to create individual cells that are typically no bigger than 300 square feet. Plastic sheeting is placed over the gravel to prevent water required for hydration from percolating through the gravel. No. 5 rebar (12 inches on center with lateral bracing that is 16 inches on center) provides additional strength and minimizes cracking.

To ensure that enough water is available for hydration, sandbags are placed over each new pad and watered regularly. After several days of curing, gravel is placed in the gap up to the level of the existing asphalt and then coldpatch asphalt is added and compacted to create a level surface for aircraft use. Asphalt sealant is then spread over the asphalt and the cold-patch to waterproof

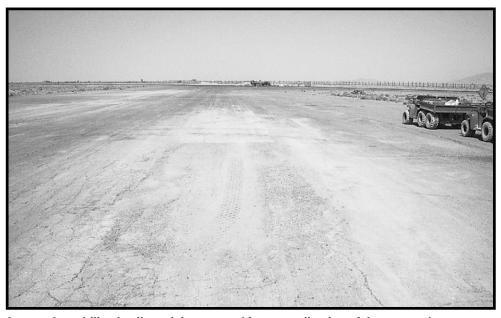
A recently stabilized soil patch is prepared for an application of dust control agent.

The early steps in this method mirror those of a preplanned concrete patch. A square or rectangular patch is cut and excavated down to the level of the subgrade. Then 2-inch slump concrete is placed in 2- to 3-inch lifts, raked of large aggregate, and covered with a thin layer of coarse sand. This process is repeated until the grade of the existing asphalt pavement is reached.

The last step of the method involves dust control. To prevent "brown-out" conditions that hamper visibility, EK 35®, a commercial dust control agent, is spread over the soil patches in several thin coats until the agent begins to pool. This nonflammable, noncorrosive binding agent not only prevents brownouts, it actually increases the durability of the soil patch. The dust control agent has been so successful that it has been used on many of the high-traffic shoulder areas of the airfield and on many of the helicopter landing zones throughout the Afghanistan area of operations.

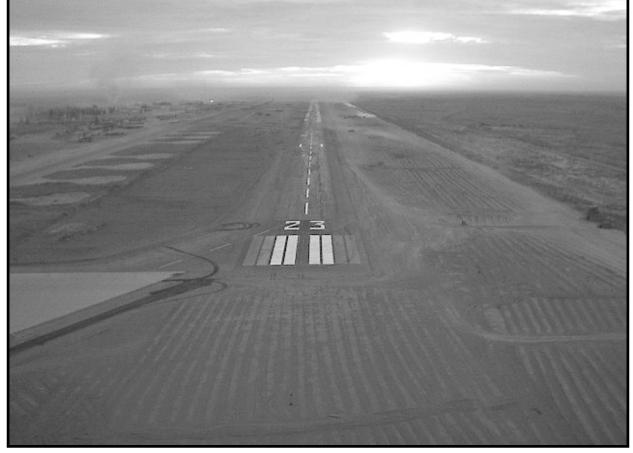
An overhead view of Runway 23 shows that Federal Aviation Administration-approved reflective paint, plus a recent application of asphalt sealant, can make a runway look new despite its age.
